West Side Gardens Treatment Plan
Alcatraz Island October 2008

BACKGROUND AND PLANNING CONTEXT

WEST SIDE GARDENS

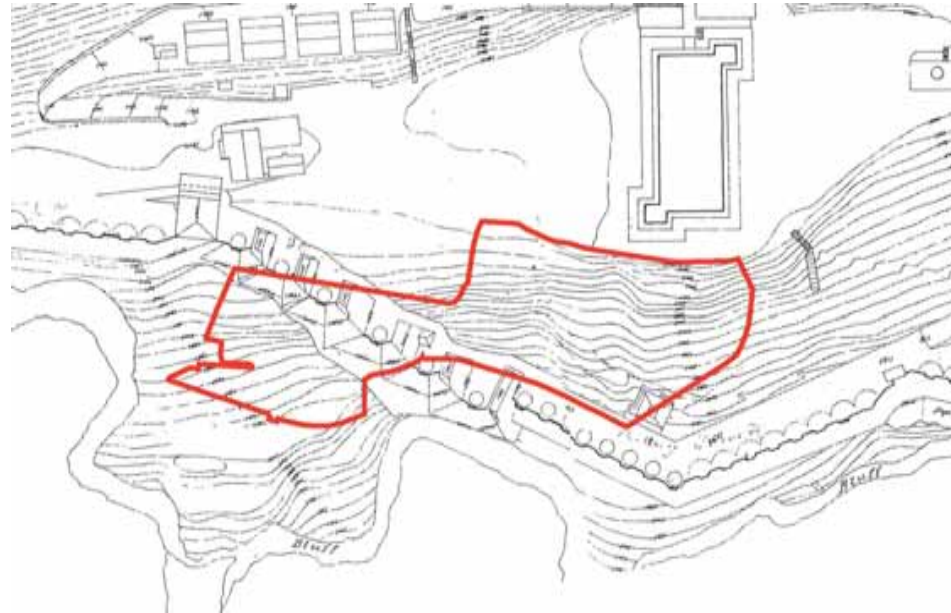
1863, showing masonry batteries and citadel

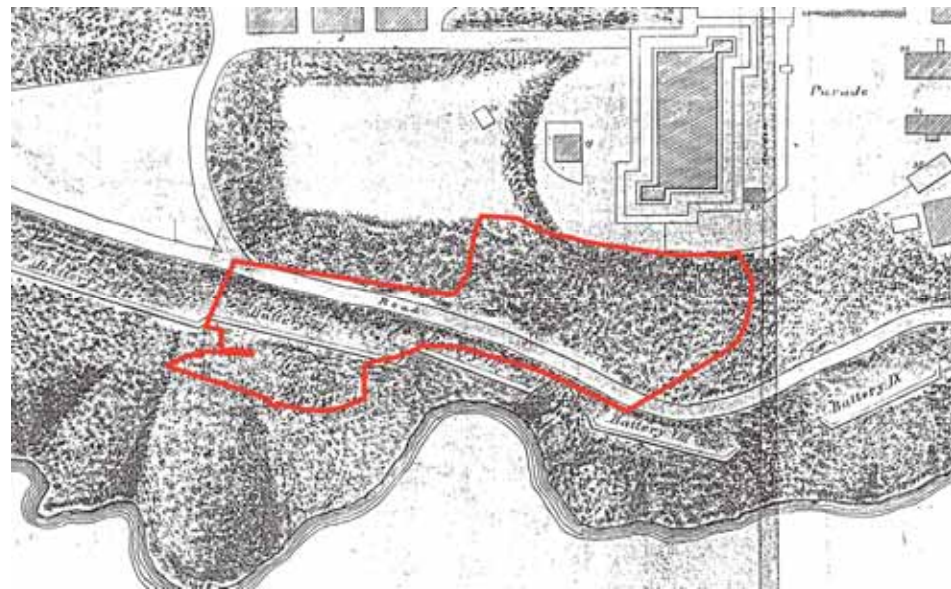
1879, showing lower road extending to west side, earthen batteries, and citadel

that continued around the south end of the island to the west side (this is the site of today's lower road at the edge of the current Parade Ground that intersects with West Road at the base of the Toolshed Terraces).

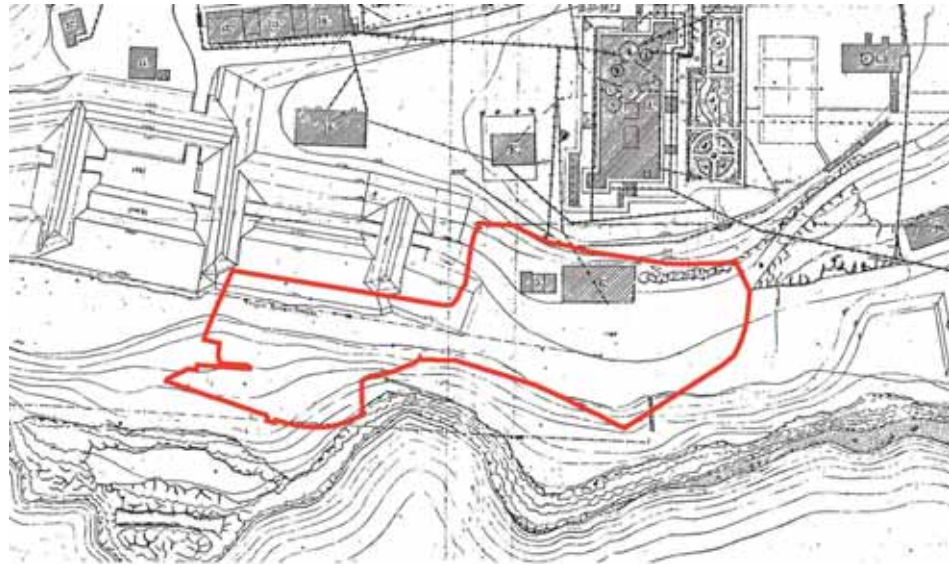
1894, showing batteries, stable, and citadel

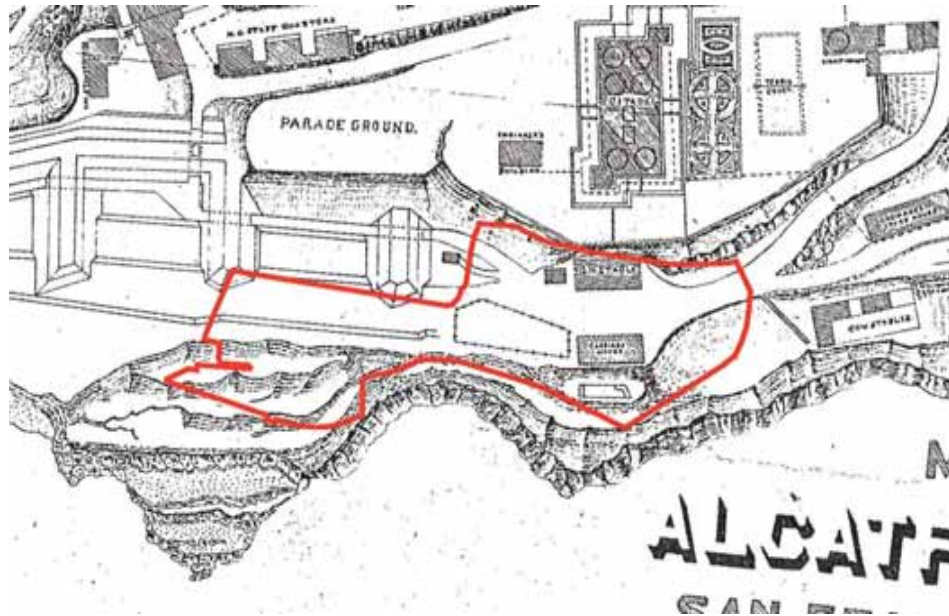
1905-1907, showing batteries, stable, corral, and carriage house

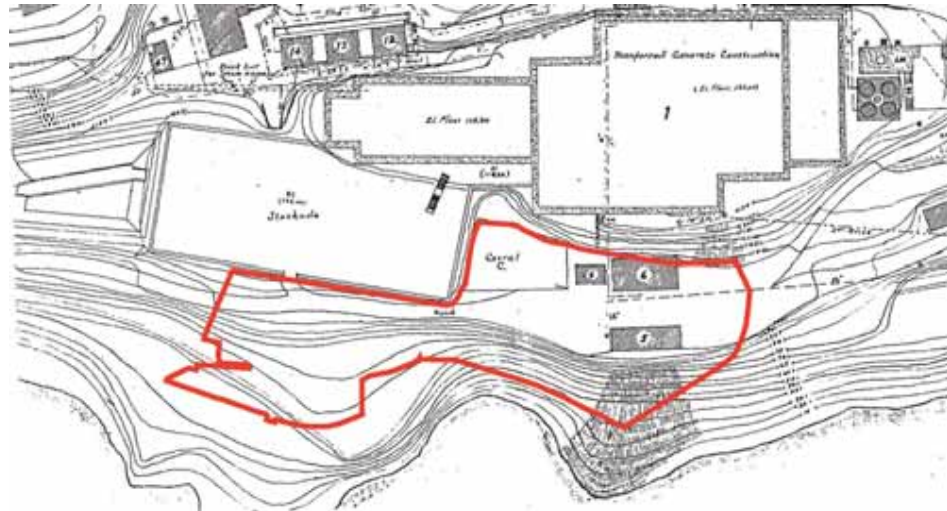
1909, showing new cellhouse and recreation yard. Stable (6), corral, and carriage house (5) remain.

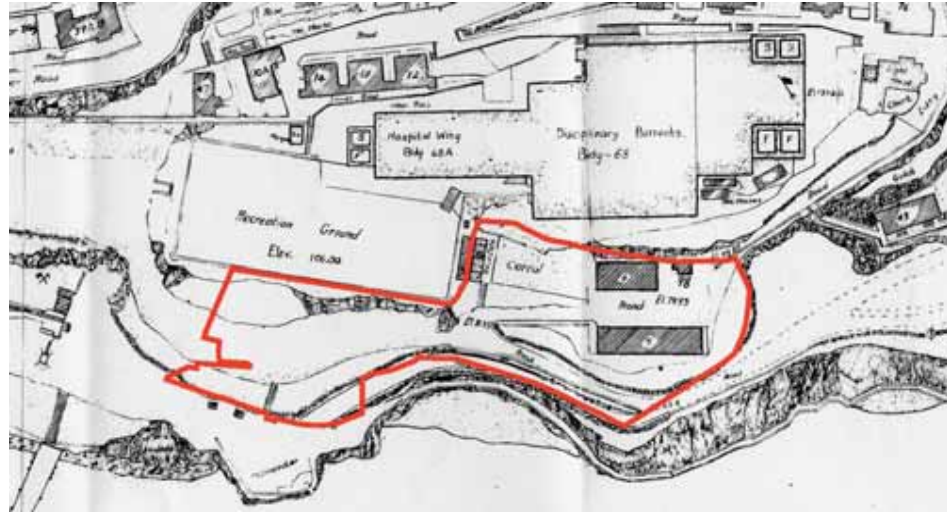
1928, showing cellhouse, recreation yard, stable (6), corral, and carriage house (5)

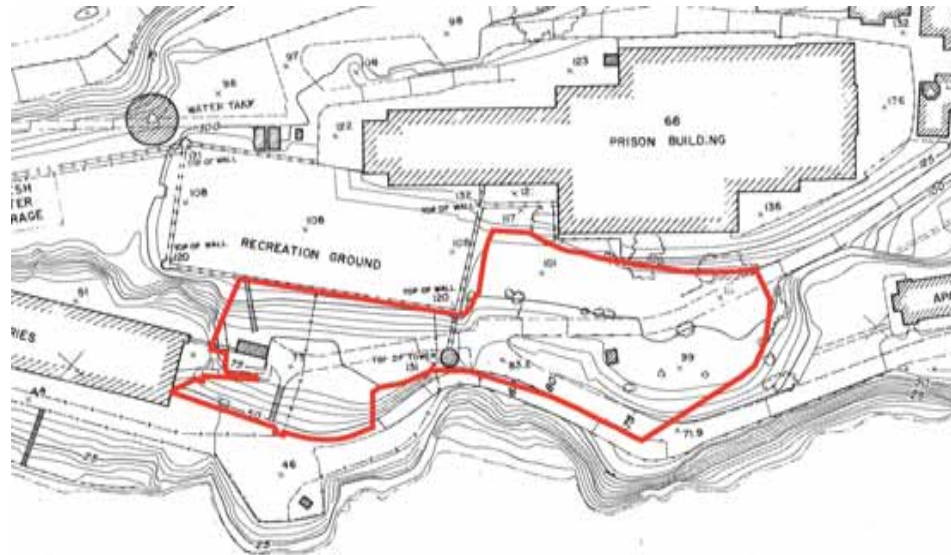
1961, showing guard tower, metal detector building, toolshed, and fences

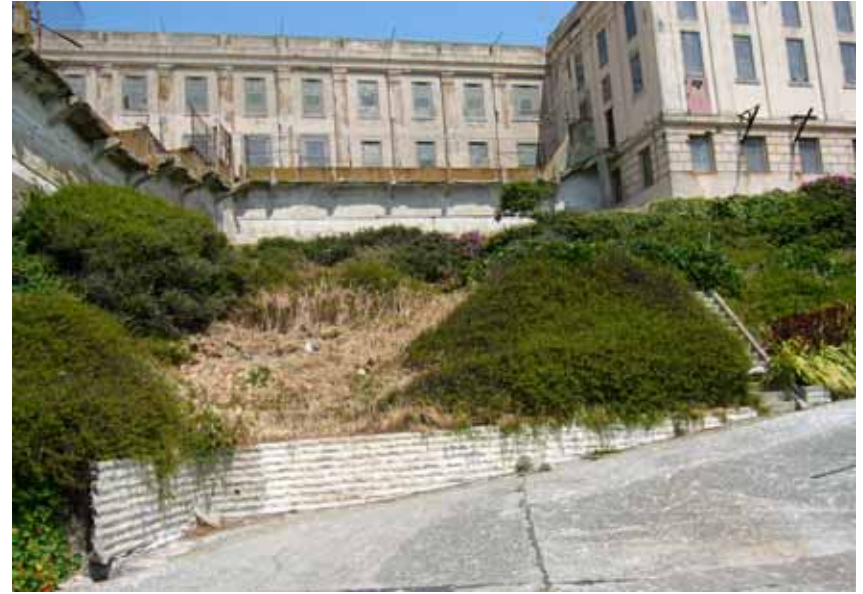
North end of West Road Terraces, showing retaining wall, summer

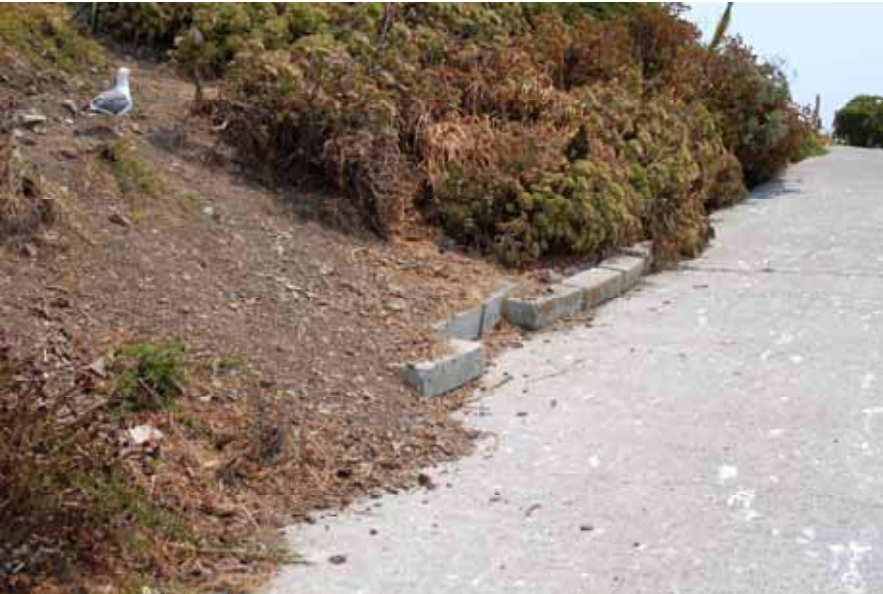
Dilapidated retaining wall and spilling dirt at West Road Terraces, summer

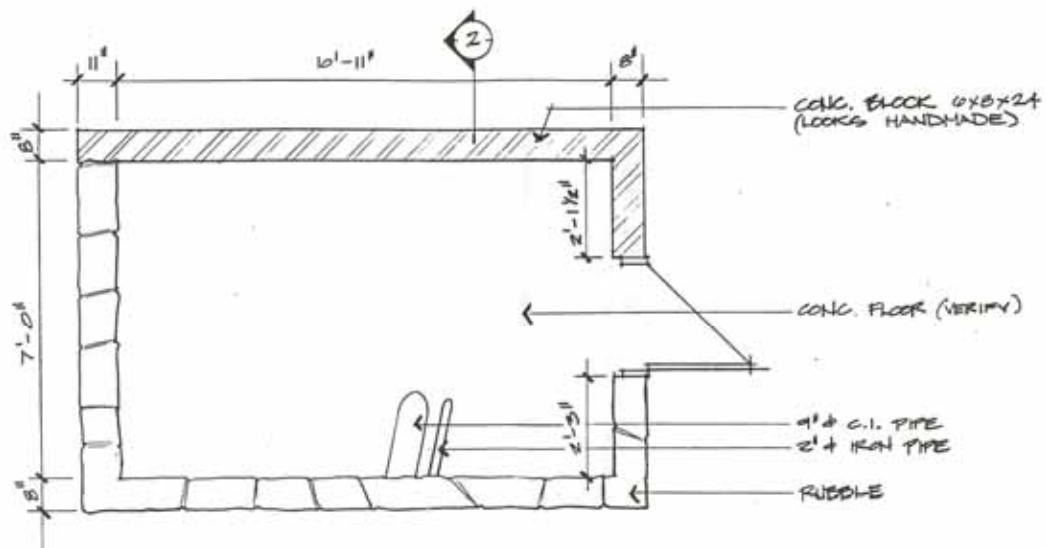
1 TOOL SHED - EXISTING PLAN
 $\frac{1}{2}" = 1'-0"$

Toolshed plan and section prepared by NPS

road; they are crumbling and need repair in places. A toolshed, originally built about 1941 and rebuilt in the 1980s, is at the top of the slope near the road and is in need of rebuilding. It is 12'5" by 8'4" and seven feet in height, and built into the grade on one side. The three-foot-high base is concrete block. The top four feet has wooden sash windows but the glass is missing from several windows. There are about six concrete steps from the road to the toolhouse. A chainlink fence and gate block access to the lower road below the Toolshed Terraces. The concrete footings from the guardtower are still in place at the guardtower site. This site has a pipe-railing barricade around two sides to restrict access. A NPS bench is installed just outside this area on the pavement.

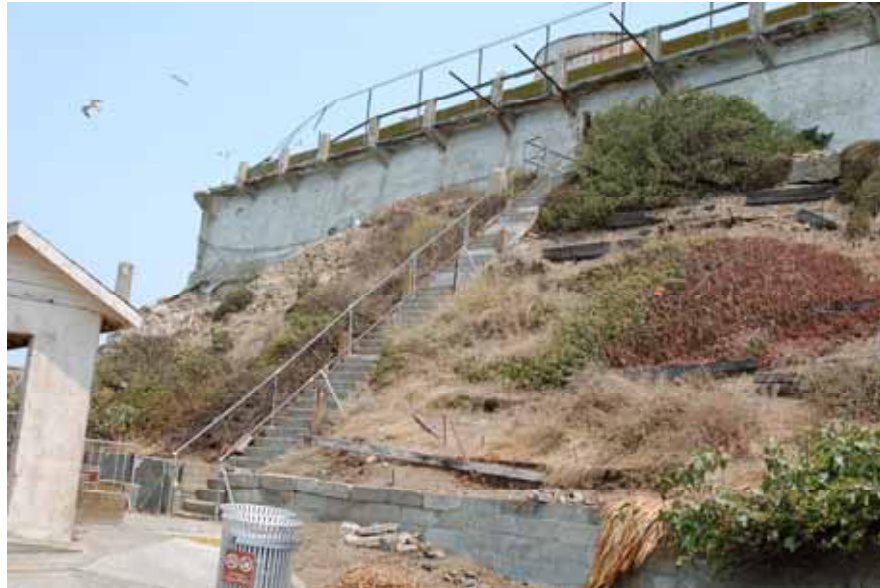
The slope continues to erode, and temporary board retaining walls, installed by the National Park Service, are failing. *Aloe* and *Drosanthemum* are the most common plant on the slope, and are threatened by aggressive honeysuckle.

Recreation Yard Slope and retaining wall at base, summer

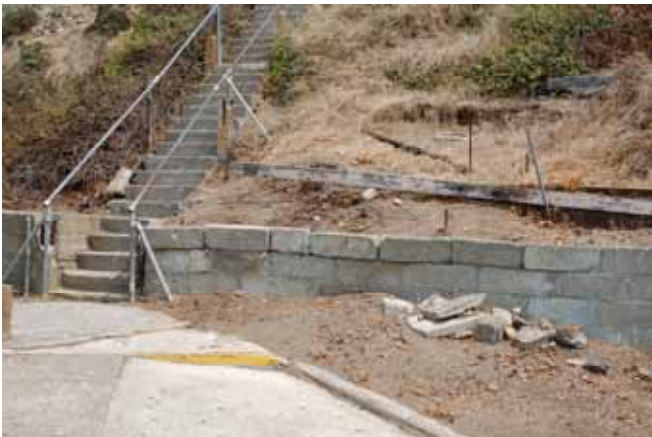
Deteriorated retaining wall at base of recreation yard stairs, summer

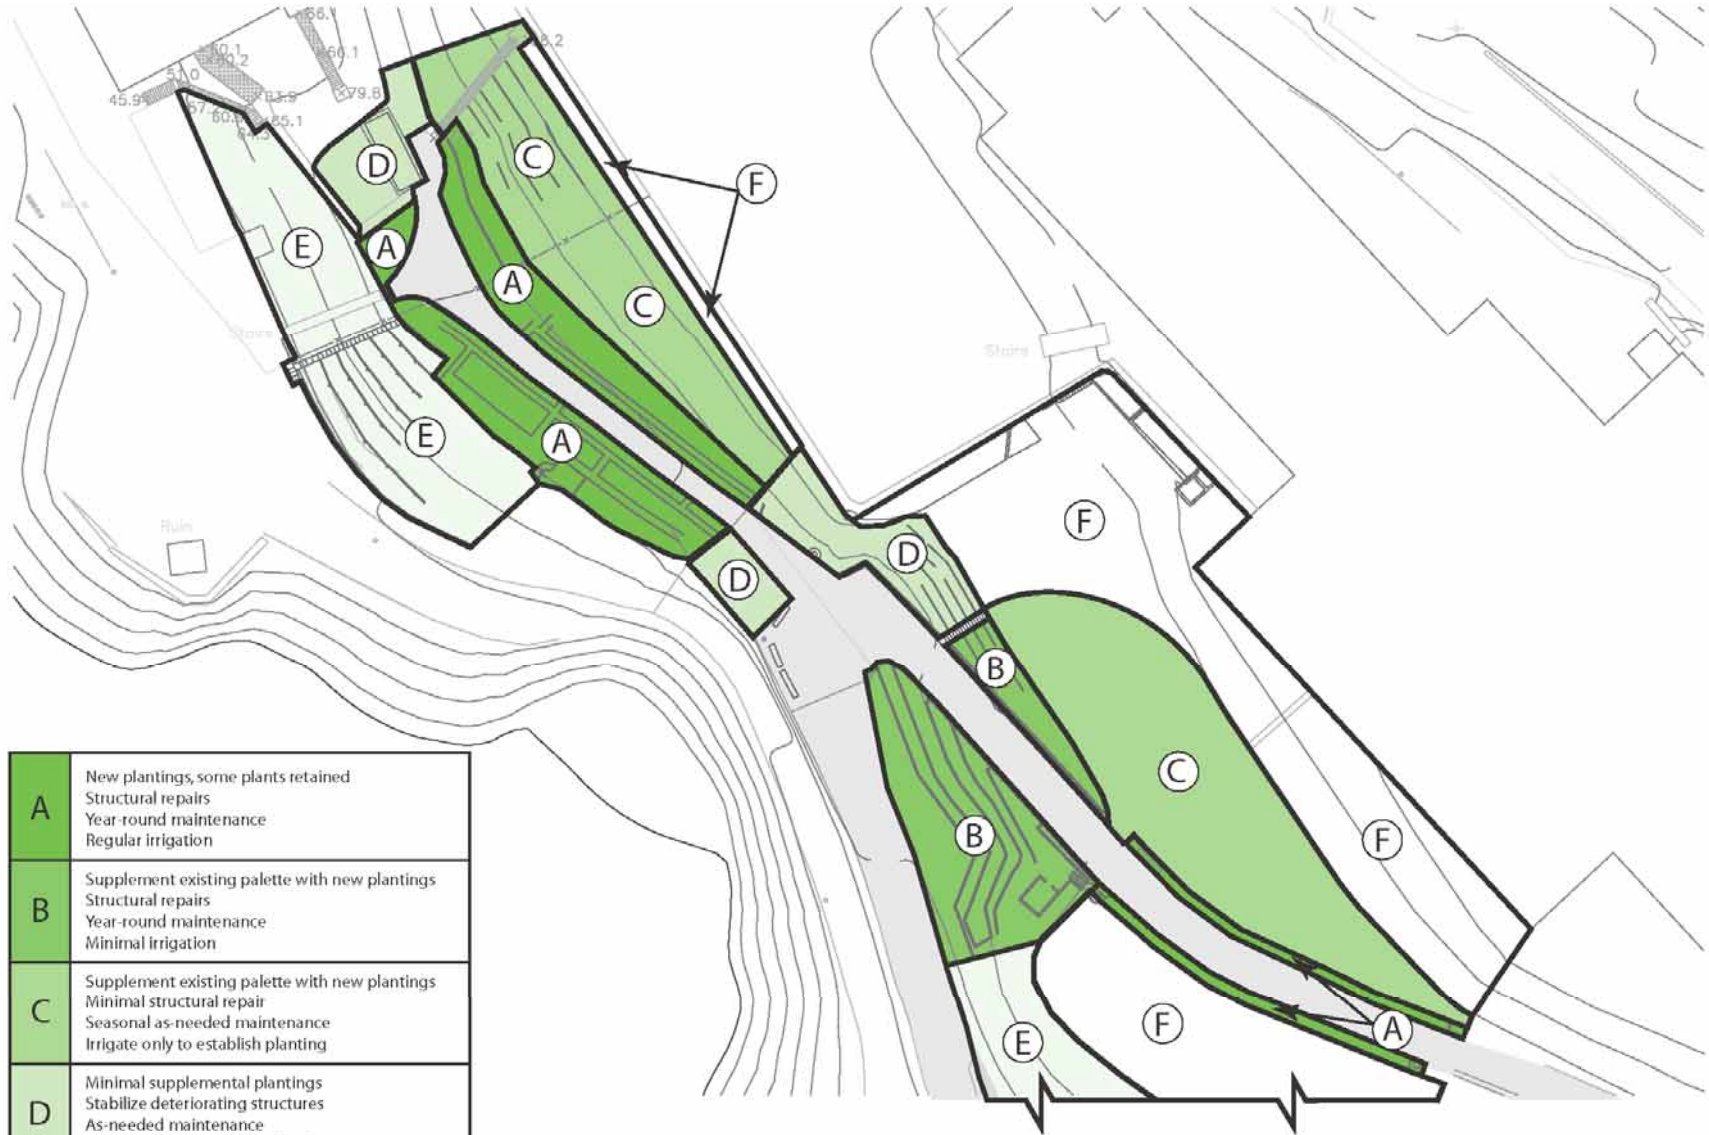
TREATMENT ZONES
ALCATRAZ WEST SIDE GARDENS

A	New plantings, some plants retained Structural repairs Year-round maintenance Regular irrigation
B	Supplement existing palette with new plantings Structural repairs Year-round maintenance Minimal irrigation
C	Supplement existing palette with new plantings Minimal structural repair Seasonal as-needed maintenance Irrigate only to establish planting
D	Minimal supplemental plantings Stabilize deteriorating structures As-needed maintenance Irrigate only to establish planting
E	Potential future supplemental planting Stabilize deteriorating structures Seasonal as-needed maintenance No irrigation
F	Garden Margins - Maintenance by NPS
